ActiveTwo EEG Electrode Service Information:

ActiveTwo EEG Electrode Service Information – 2

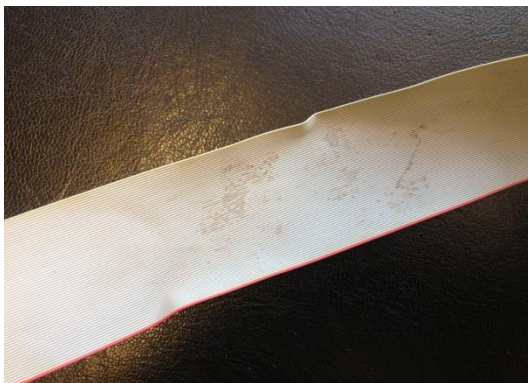
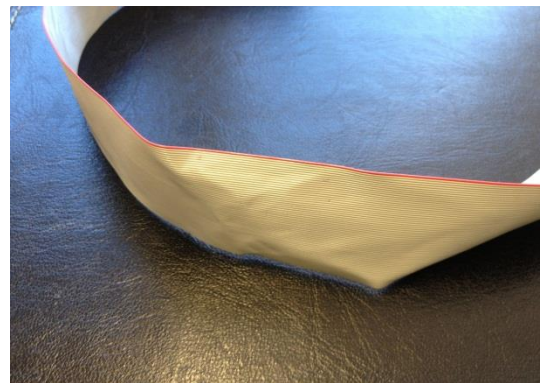
- 1) Serial Numbers starting with **AS04; AS07, FR07, FR09, FR10, FR11** are out of warranty and must be replaced!
- 2) Serial Numbers starting with **FR12, FR13, FR14** are out of warranty but may be repaired if the following conditions are met (**repairs are charged for as per our prices overleaf**):
 - a) The set is in good condition, and only a maximum of 2 electrodes are broken in that set
 - b) The sets were never repaired before
 - c) The sets have been cleansed and unkinked before sending unlike some samples below:

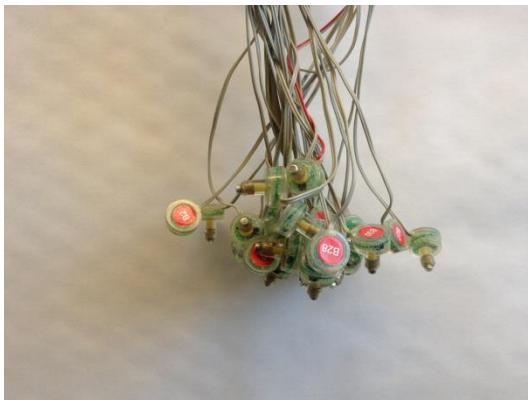
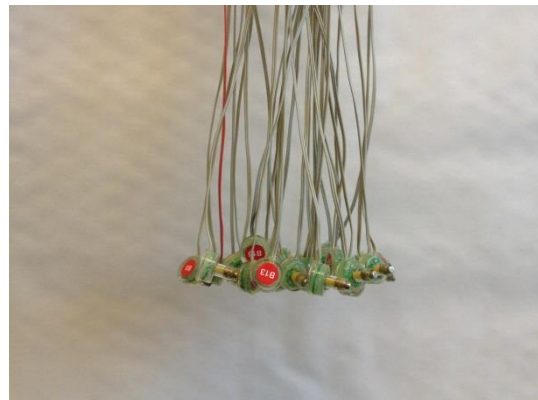
- d) All electrodes are untangled as picture left compares to the right picture:

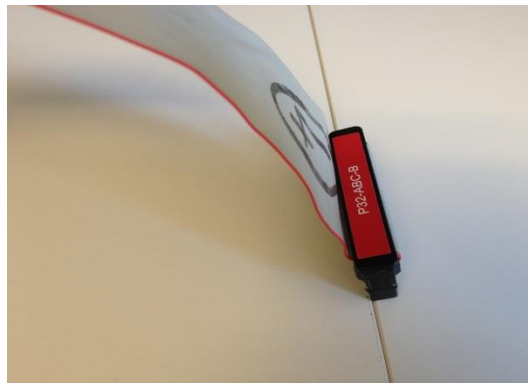
- e) If SCSI connectors attached to the cable have been kinked (this happens when the amplifier sits in front of the subject and so cables have been bent 180 degrees toward the subject) such as pictures below, we will replace the SCSI connector and charge for the service as overleaf:

Please note that kinked SCSI connectors cause intermittent disconnection especially of either the first or the last electrode in that set!

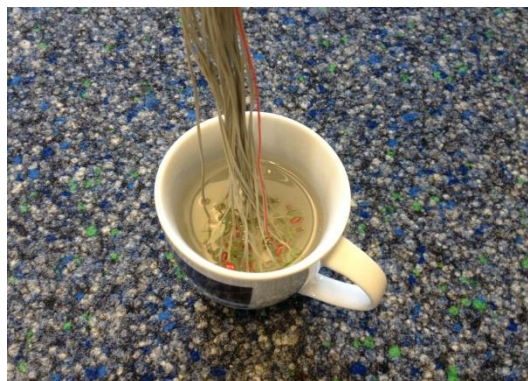
- f) It does often happen, that electrodes have never been cleansed in a water bath properly (see picture below), and so gel hardens on the tips and electrodes then behave very strangely (high offsets, or no changing offsets at all may result from that); if we receive electrodes contaminated with gel, we will charge maintenance fee for cleansing, and checking. We advise before sending, to immerse the entire set in distillate water for around 2 hours and then recheck. See picture below:

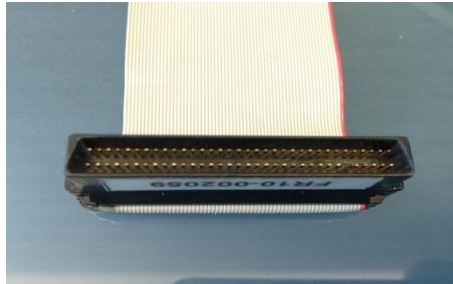
- g) Bent SCSI Pins inside connector or gel bridge near some pins inside the SCSI connector as follows will lead to problems and the defective connector should be replaced (a bent pin is the cause of a user pushing the connector onto the socket to hardly, hence causing bending of the pin. In some cases that even leaves plastic residual in an adjacent hole and so causing quite some problems. Worst case: the SCSI port on the AD Box needs to be replaced) :

Please note that bent pins will show on a channel either a high offset, or cause a short to other channels!
